American Home Inspections of NE NC

Property Address US Coast Guard Housing, Unit #46017

Inspector Name Ralph W. Woodard, NC Licensed Home Inspector #493
Company Name American Home Inspections of NE NC
Company Address PO Box 2347
City Kitty Hawk State NC Zip 27949
Phone Cell 25 202 8344 Fax x
E-Mail ralphdubya@embargmail.com

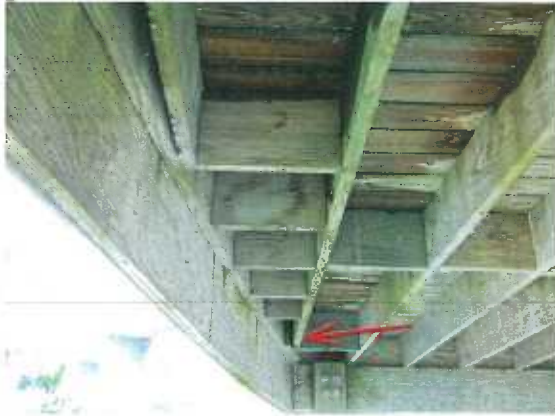
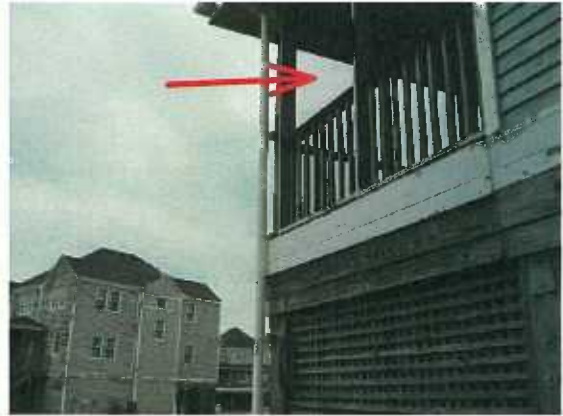
| 4. | <input type="checkbox"/> | <input type="checkbox"/> | <input type="checkbox"/> | <input type="checkbox"/> | <input checked="" type="checkbox"/> | Deck: Front, Pressure Treated Wood There are two floor joist near the front of the deck that is not properly supported with a metal joist hanger. Several of the handrail pickets are loose and out of place. Close inspection revealed that the nails used to fasten the pickets to the top and bottom rails are rusty and deteriorated and failing to perform their intended function. |

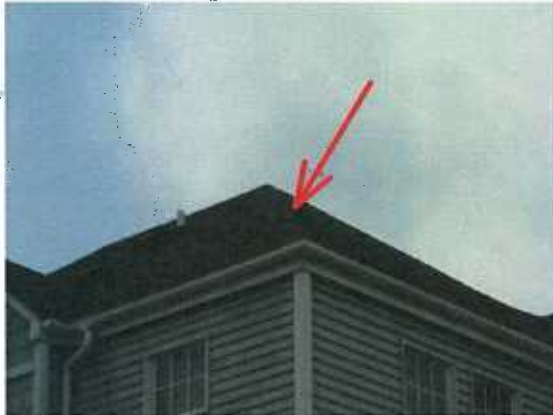
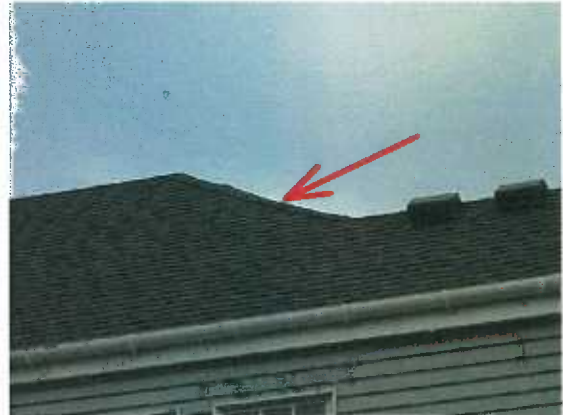
1. Method of Inspection: On roof
2. ☐ ☐ ☐ ☐ ☒ Material: Asphalt shingle There are ridge cap shingles missing from the roof in two places.

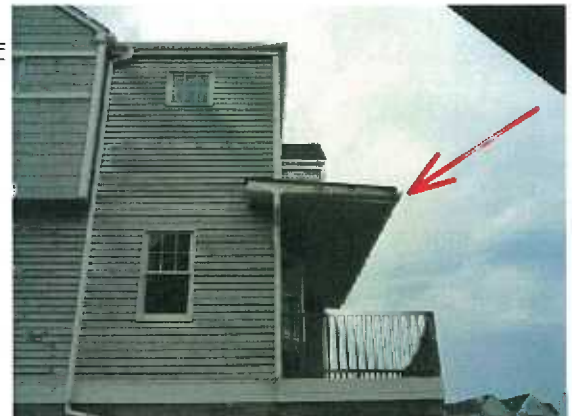
1. ☒ ☐ ☐ ☐ ☐ Structure Type: Wood frame
2. ☐ ☐ ☐ ☐ ☒ Foundation: 8X8 PT Wood Pilings and Monolithic Concrete Foundation The roof above the front deck, this roof is sloping downward at the outer edge. This condition probably exist because this is a single unit and there is no party wall to support the roof on the south side.

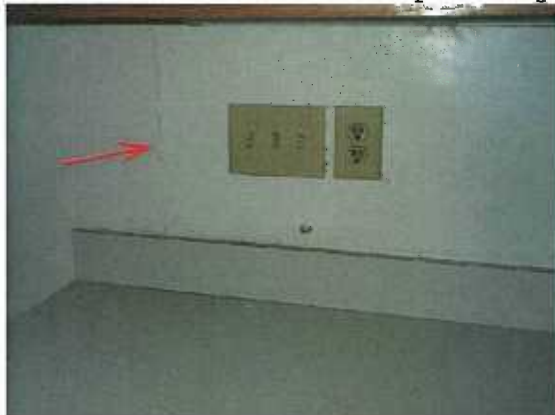
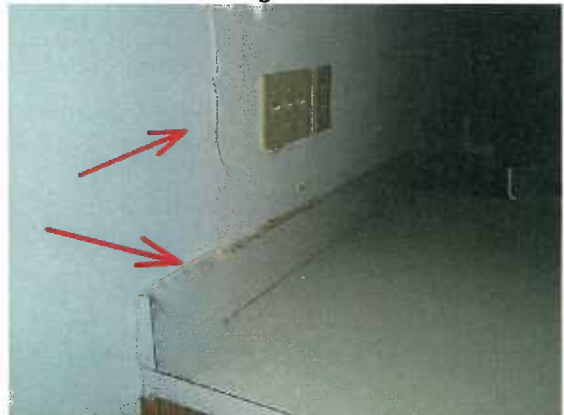
| 11. | <input type="checkbox"/> | <input type="checkbox"/> | <input type="checkbox"/> | <input type="checkbox"/> | <input checked="" type="checkbox"/> | Walls: Drywall The drywall between the bottom of the wall cabinets and the laminate top just to the left of the range. There is a crack in the drywall surface and the drywall appears deteriorated. The moisture causing this deterioration is probably coming from the exterior of the house since there is no plumbing above this damage. |

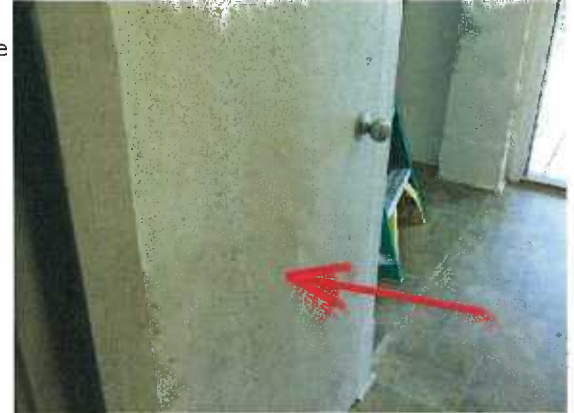
1. ☒ ☐ ☐ ☐ ☐ Ceiling: Drywall
2. ☐ ☐ ☐ ☒ ☐ Walls: Paneling, Painted There is presence of organic growth on the painted plywood walls of this room.
3. ☒ ☐ ☐ ☐ ☐ Floor: Concrete
4. ☐ ☐ ☐ ☒ ☐ Doors: Painted, Flush Solid Core There is organic growth on the surface of the door.

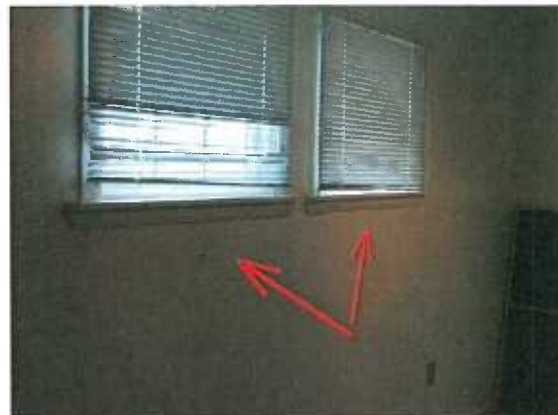
26. ☐ ☐ ☐ ☒ ☐ Windows: Andersen Fixed Glass There are stains on the wall under the top fixed glass windows.

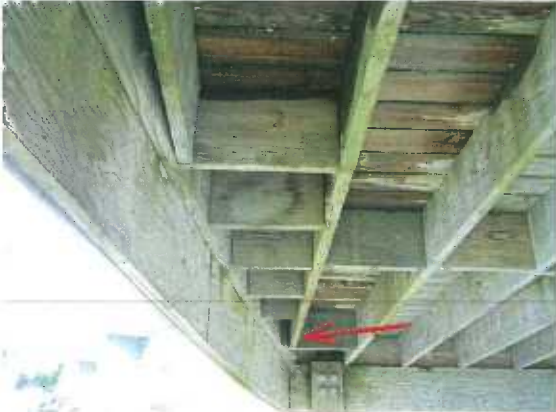
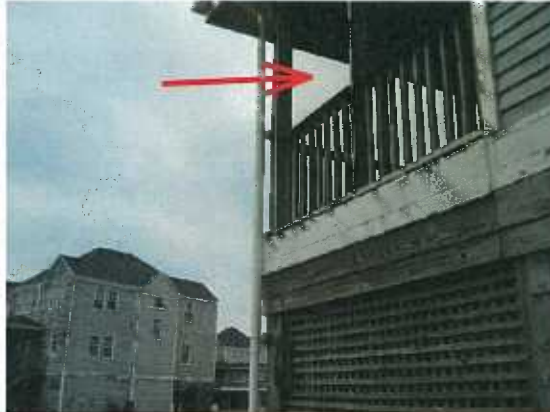
1. **Deck: Front, Pressure Treated Wood** There are two floor joist near the front of the deck that is not properly supported with a metal joist hanger. Several of the handrail pickets are loose and out of place. Close inspection revealed that the nails used to fasten the pickets to the top and bottom rails are rusty and deteriorated and failing to perform their intended function.

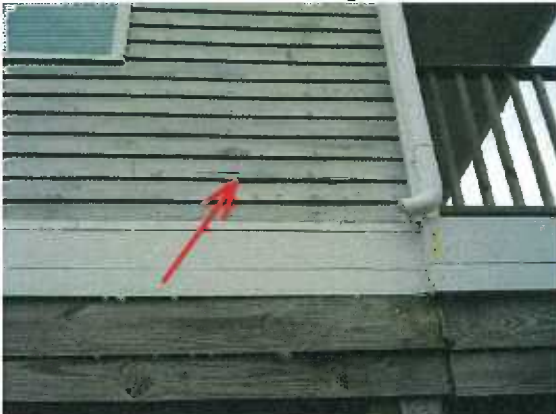
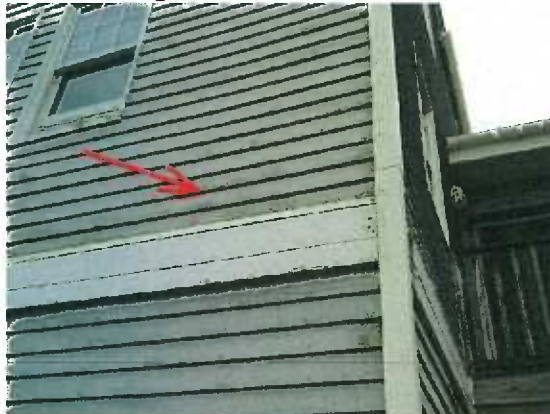
2. **Porch: Rear Porch, Pressure Treated Wood** Screen panels for the porch are missing or damaged.
3. **Stairs/Landing: Rear Stairs & Landing, Pressure Treated Wood** The wood pickets are loose or out of place. The nails used to secure the pickets are rusty/deteriorated.
4. **Exterior Walls Exterior Surface Type: Horizontal Wood Ship Lap Siding** There is organic growth on the siding in several places. There is one piece of siding on the south side that is deteriorated. The exterior of the house should be pressure washed and repainted.

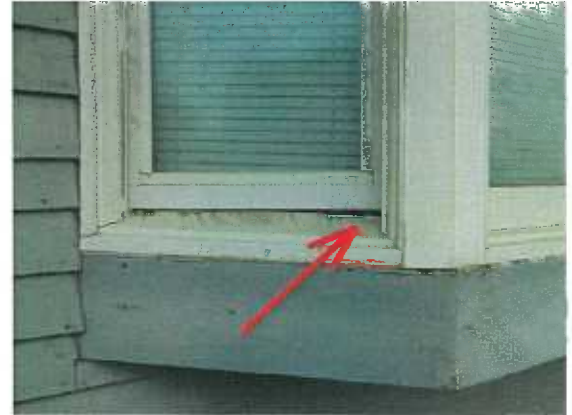
5. **Windows:** Andersen Double Hung, Tilt & Wash Feature
The bay window in the kitchen eating area, the outer edge of this window unit is bowing down, causing the openings for the double hung windows on the sides to be out of square, keeping the double hung window from being closed properly.

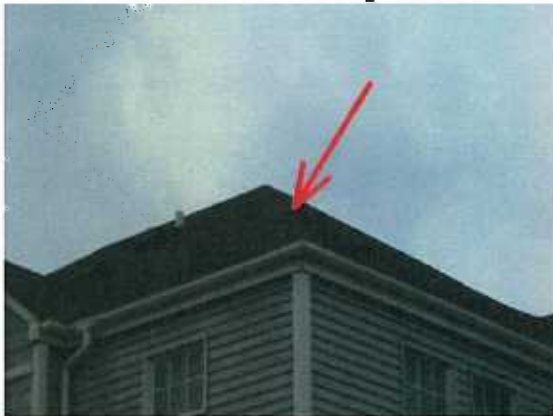
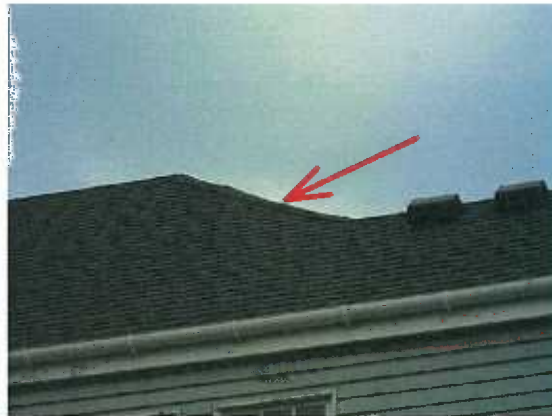
7. **All Roof Areas Roof Surface Material:** Asphalt shingle There are ridge cap shingles missing from the roof in two places.

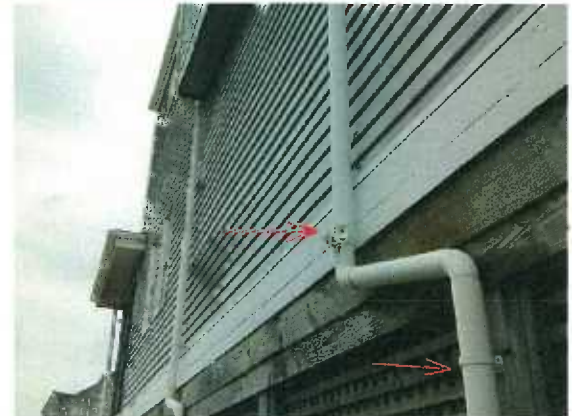
8. **Downspouts:** Plastic Parts of the gutter down spouts are missing and not properly attached to the building.

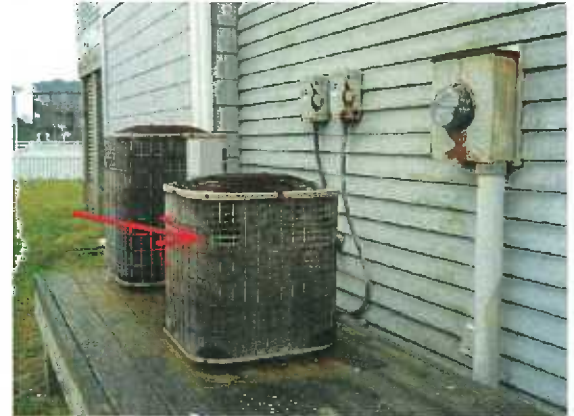
15. North Side AC System Visible Coil: Copper core with aluminum fins The aluminum fins surrounding the copper coil are becoming deteriorated and falling away from the copper coil. The aluminum fins are present to dissipate the heat from the copper coil and when the fins are no longer present the coil will over heat and the condenser will cease to function.

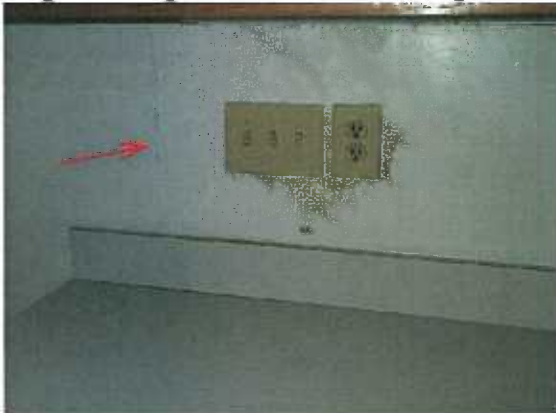
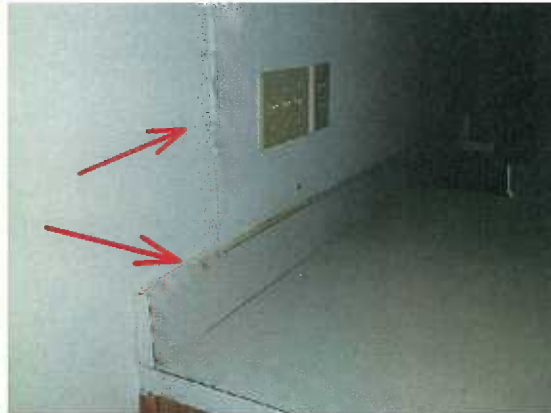
17. Kitchen & Dining Area, Main Level Kitchen Walls: Drywall The drywall between the bottom of the wall cabinets and the laminate top just to the left of the range. There is a crack in the drywall surface and the drywall appears deteriorated. The moisture causing this deterioration is probably coming from the exterior of the house since there is no plumbing above this damage.

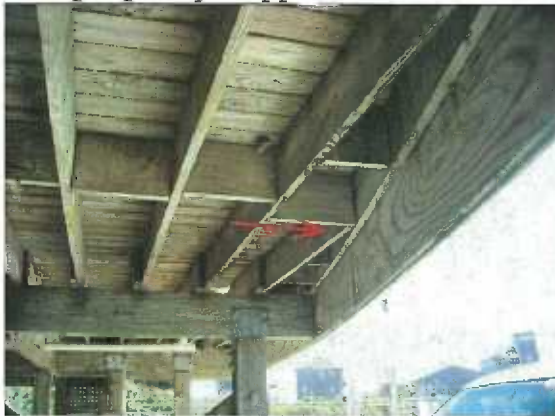
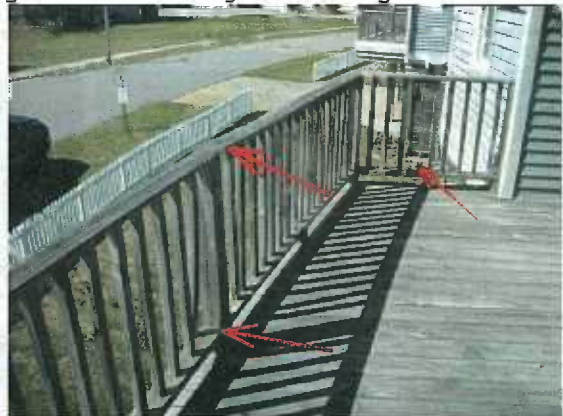
Deck: Front, Pressure Treated Wood There is one deck floor joist that is not properly supported with a ledger or metal joist hanger.

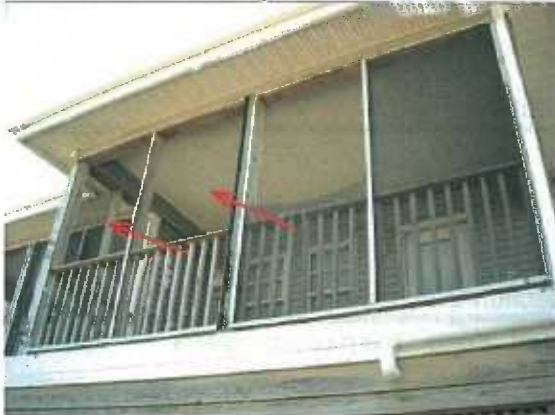
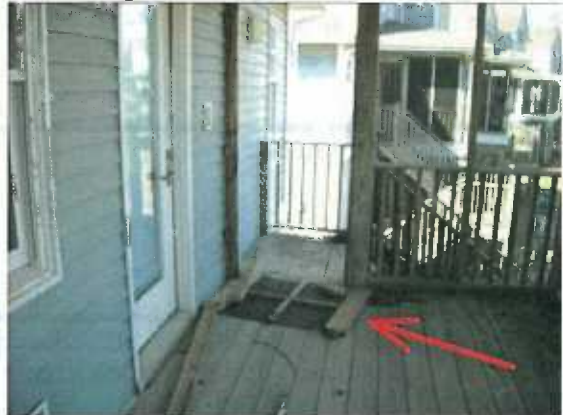
Porch: Rear Porch, Pressure Treated Wood Screen panels for the porch are missing or damaged. The porch floor ledger is not bolted to the structure. The porch screen door is damaged.

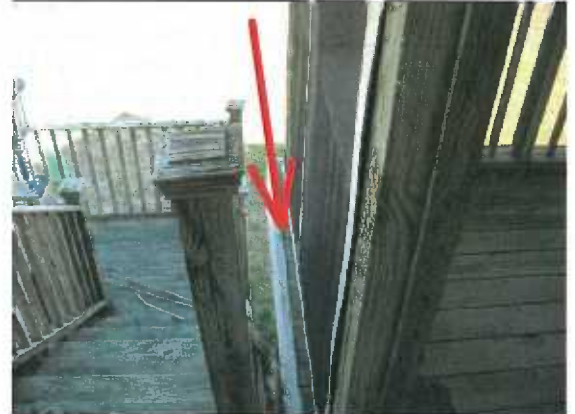
4. ☐ ☐ ☐ ☐ ☒ Stairs/Landing: Rear Stairs & Landing, Pressure Treated Wood There is an open space between the porch post and the stairs handrail. The space is about 12 inches. A small child could fall from this open area.

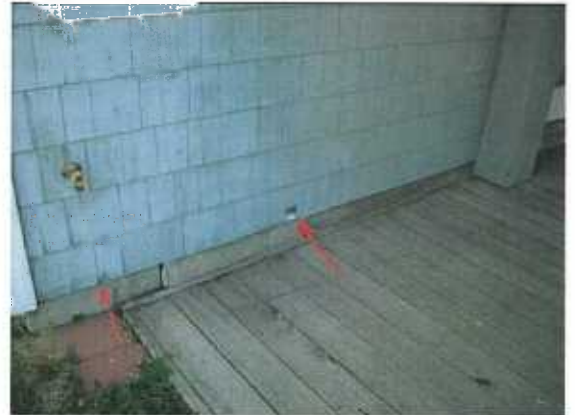
7. ☐ ☐ ☐ ☒ ☐ Type: Plywood Panels with machine shake appearance. The bottom course of shake panels on the front and side of the unit are damaged. It appears the siding was damaged with a power weed eater.

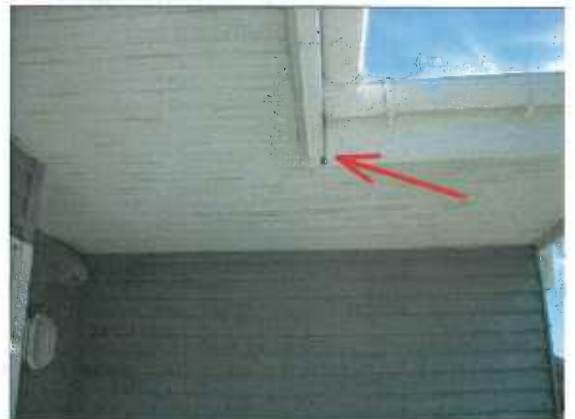
9. ☒ ☐ ☐ ☐ ☐ Fascia: Wood, wrapped with Aluminum Coil Stock There is a 1/4 inch gap between the aluminum wrapping the wood fascia.

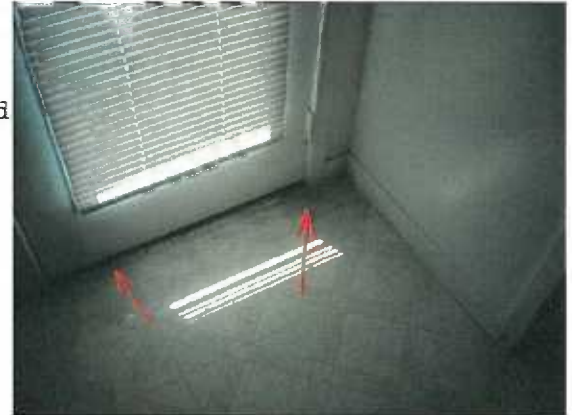
14. ☐ ☐ ☐ ☐ ☒ Entry Door: Kitchen/Dining Area, Fiberglass, Fullview Glass Moisture is migrating to the inside at the door threshold. The door and threshold need to be adjusted to stop the moisture migration.

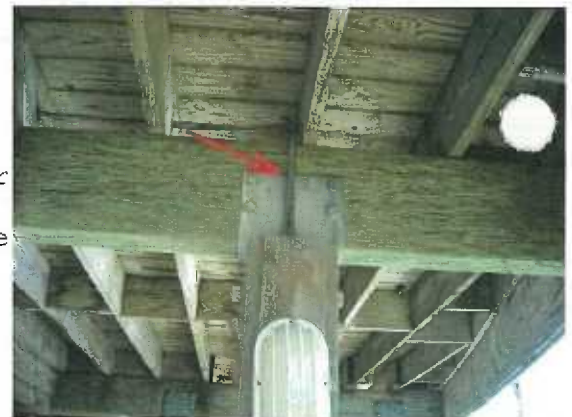
17. ☐ ☐ ☐ ☒ ☐ Exterior Lighting: Exterior, Surface Mount There is a exterior light under the front deck that was wired with underground romex wiring that should have been installed in electrical conduit. There is a light installed for the rear stairs. The underground romex wiring for this light should have been installed in electrical conduit.

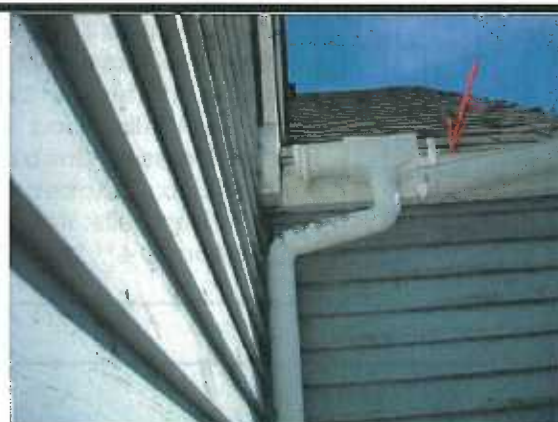
9. ☐ ☐ ☐ ☐ ☒ Gutters: Plastic The glue has failed at one of the sections of plastic gutter pipe. This is allowing moisture to fall into one of the corners of the party wall.

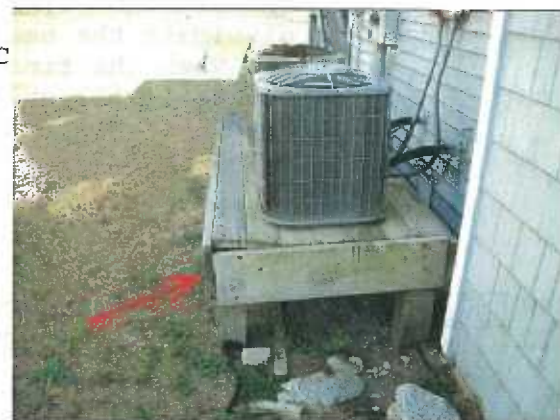
1. ☐ ☐ ☐ ☐ ☒ A/C System Operation: Appears serviceable
2. ☒ ☐ ☐ ☐ ☐ Condensate Removal: Plastic tubing
3. ☐ ☐ ☐ ☐ ☒ Exterior Unit: Mounted on wooden platform
The wooden platform supporting the HVAC condensers has failed and should be repaired.

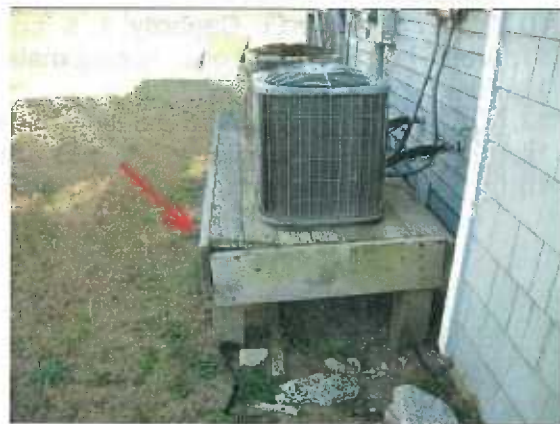
11. ☐ ☐ ☐ ☐ ☒ A/C System Operation: Inoperative The unit is nearing the end of the manufactures stated design life, A qualified air conditioning contractor is recommended to evaluate and estimate repairs
12. ☒ ☐ ☐ ☐ ☐ Condensate Removal: Plastic tubing
13. ☐ ☐ ☐ ☐ ☒ Exterior Unit: Mounted on wooden platform
Wooden platform is deteriorated and needs to be repaired.

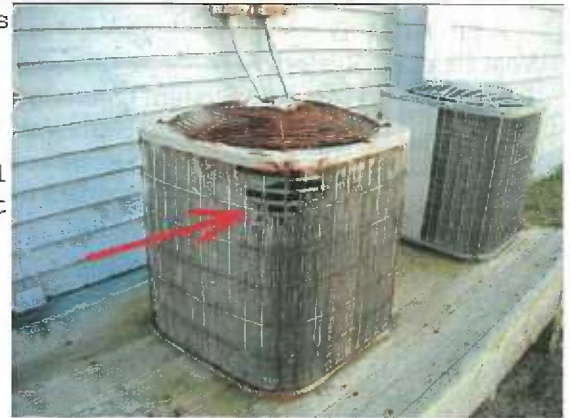
18. ☐☐☐☐☒ Visible Coil: Copper core with aluminum fins
The aluminum fins surrounding the copper coil are becoming deteriorated and falling away from the copper coil. The aluminum fins are present to dissipate the heat from the copper coil and when the fins are no longer present the coil will over heat and the condenser will cease to function.

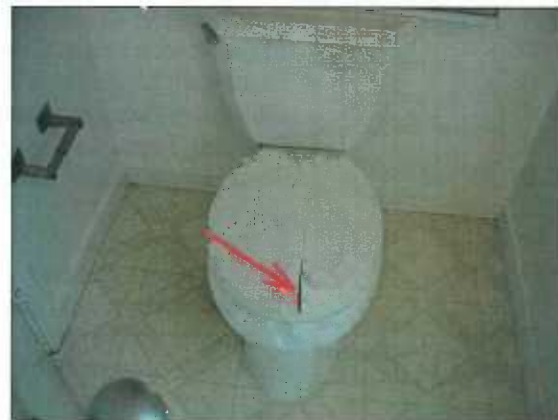
1. ☒ ☐ ☐ ☐ ☐ Ceiling: Drywall
2. ☒ ☐ ☐ ☐ ☐ Walls: Drywall
3. ☒ ☐ ☐ ☐ ☐ Floor: Vinyl floor covering
4. ☒ ☐ ☐ ☐ ☐ Doors: Painted, Flush Solid Core
5. ☒ ☐ ☐ ☐ ☐ Windows: Andersen, Double Hung, Tilt and Wash
6. ☒ ☐ ☐ ☐ ☐ Electrical: Light & Receptacle
7. ☒ ☐ ☐ ☐ ☐ Counter/Cabinet: Laminate Top & Flush Laminate Cabinet
8. ☐ ☐ ☒ ☐ ☐ Faucets/Traps: Generic
9. ☐ ☐ ☐ ☐ ☒ Toilets: Kohler The toilet seat lid is damaged.

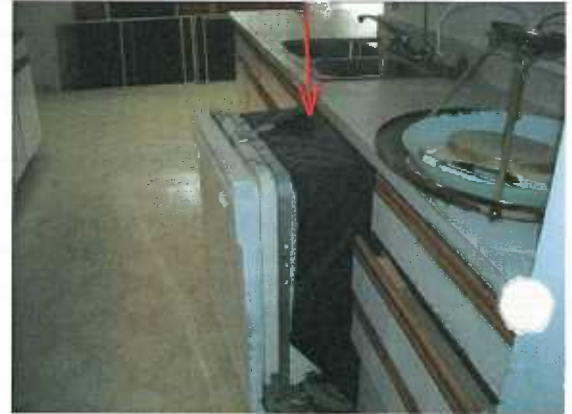
| 3. | <input type="checkbox"/> | <input type="checkbox"/> | <input checked="" type="checkbox"/> | <input type="checkbox"/> | <input type="checkbox"/> | Dishwasher: General Electric Dishwasher is not installed in its proper place. |

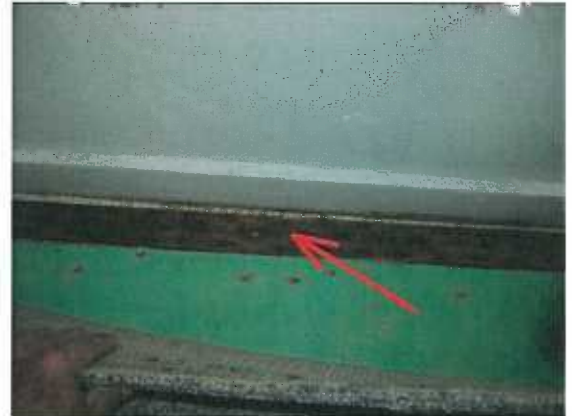
1. ☐ ☐ ☐ ☒ ☐ Closet: Two Closets The carpet in these closets are stained along the party wall.

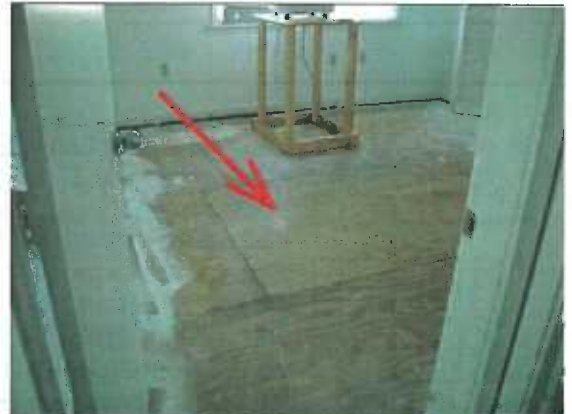
2. ☒ ☐ ☐ ☐ ☐ Ceiling: Drywall
3. ☒ ☐ ☐ ☐ ☐ Walls: Drywall
4. ☐ ☐ ☐ ☐ ☒ Floor: Carpet The carpet and padding has been removed from this room.

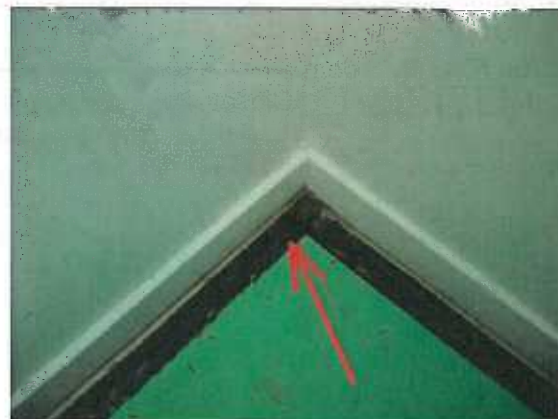
12. ☐ ☐ ☐ ☐ ☒ Floor: Carpet The carpet is stained at the front left corner of the room in the area of the party wall.

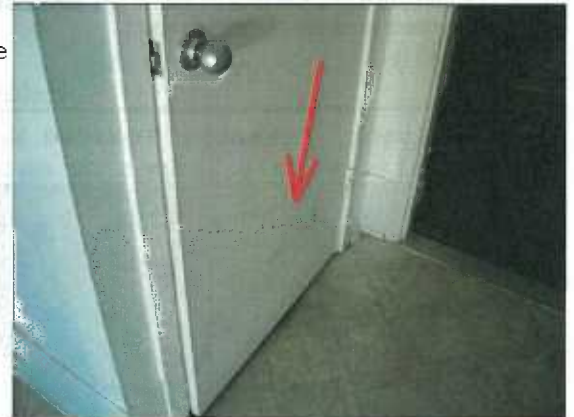
19. ☐ ☐ ☐ ☒ ☐ Doors: Painted, Flush Solid Core There is organic growth on the surface of the door.

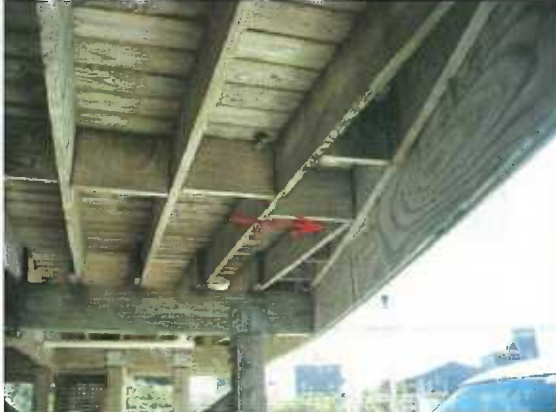
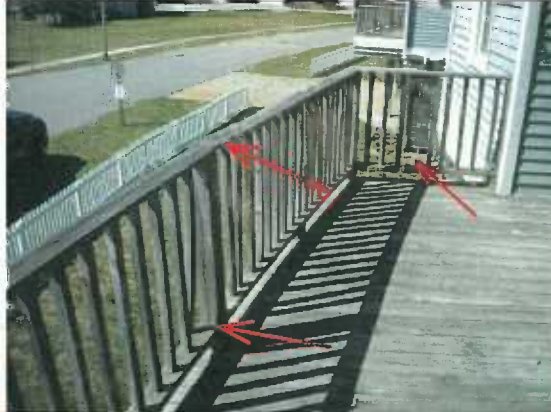
1. Deck: Front, Pressure Treated Wood There is one deck floor joist that is not properly supported with a ledger or metal joist hanger.

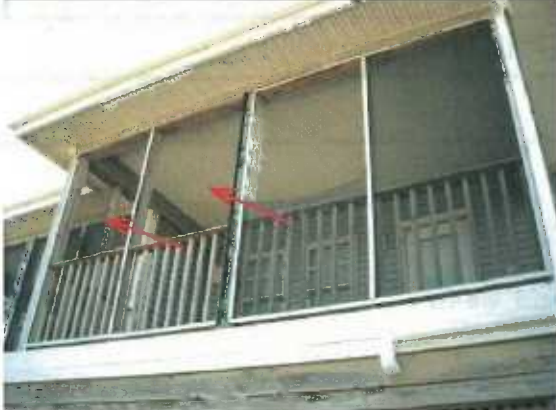
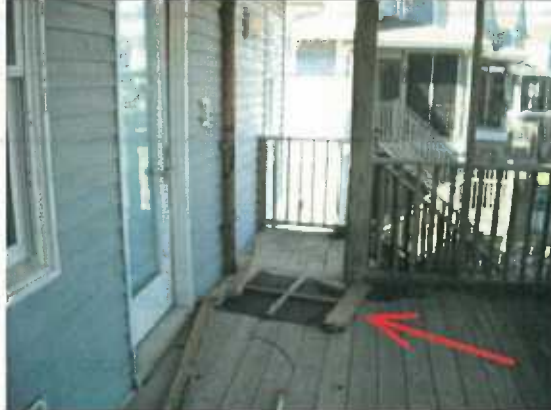
2. Porch: Rear Porch, Pressure Treated Wood Screen panels for the porch are missing or damaged. The porch floor ledger is not bolted to the structure. The porch screen door is damaged.

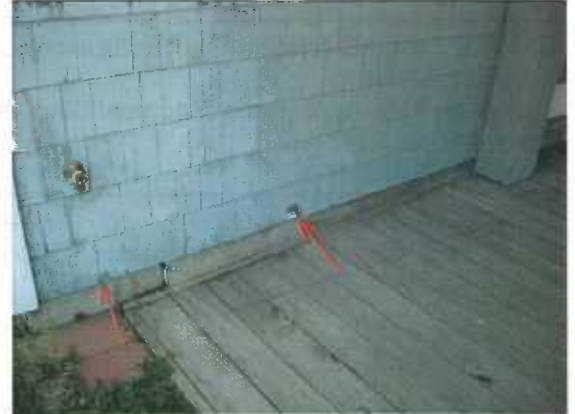
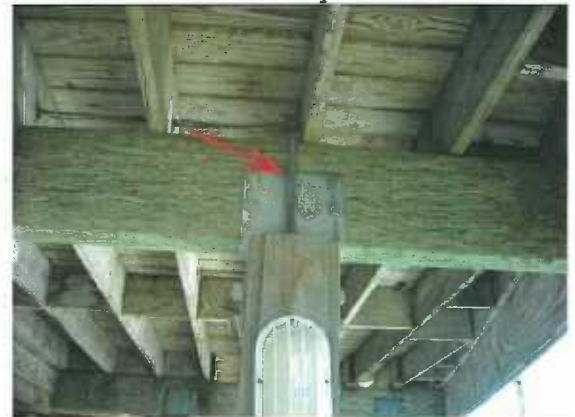
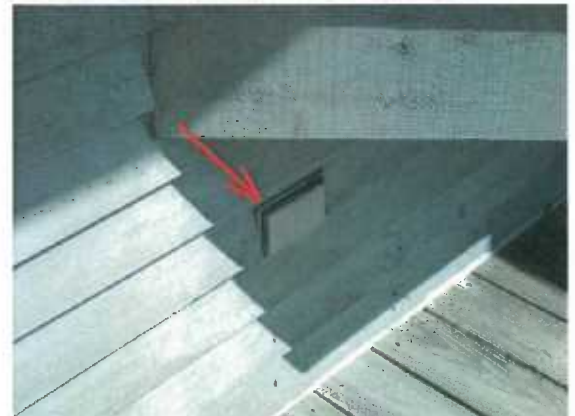
4. **Accent Walls Exterior Surface Type:** Plywood Panels with machine shake appearance. The bottom course of shake panels on the front and side of the unit are damaged. It appears the siding was damaged with a power weed eater.
5. **Window Screens:** Metal wire There are several screens at various location in the house that are not installed in the windows. No effort was made to inventory the windows.
6. **Exterior Lighting:** Exterior, Surface Mount There is a exterior light under the front deck that was wired with underground romex wiring that should have been installed in electrical conduit. There is a light installed for the rear stairs. The underground romex wiring for this light should have been installed in electrical conduit.
7. **Exterior Electric Outlets:** Exterior, Surface Mount There is an exterior outlet that is not properly installed in the wall opening.

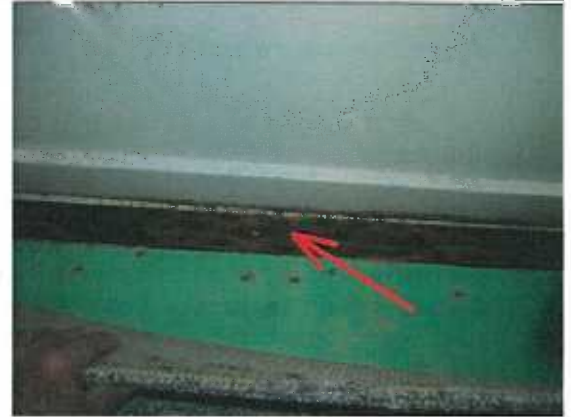
11. Top Rear Bedroom Closet: Two Closets The carpet in these closets are stained along the party wall.

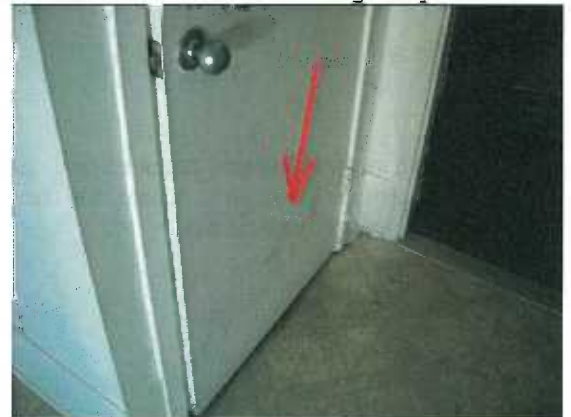
12. Ground Level Utility/Storage Room Living Space Walls: Paneling, Painted There is presence of organic growth on the painted plywood walls of this room.
13. Main Level Living Area Living Space Ceiling: Drywall There is a crack in the ceiling drywall.
14. Ground Level Entry Living Space Doors: Painted, Flush Solid Core There is organic growth on the surface of the door.

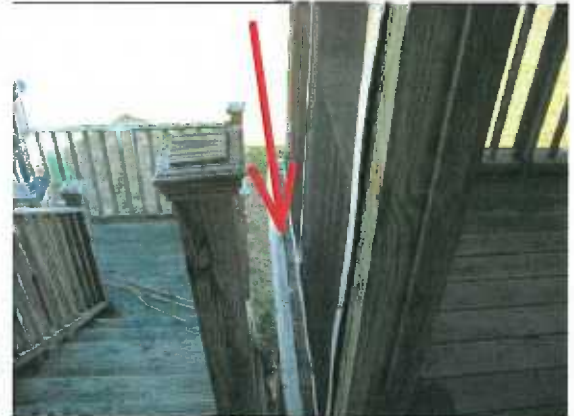
1. **Stairs/Landing:** Rear Stairs & Landing, Pressure Treated Wood There is an open space between the porch post and the stairs handrail. The space is about 12 inches. A small child could fall from this open area.

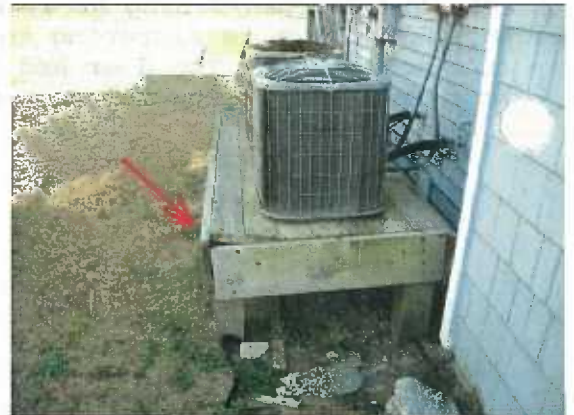
6. West Side AC System Refrigerant Lines: Rubbertex Insulation The black rubbertex insulation on the copper tubing is deteriorated and should be replaced.
7. West Side AC System A/C System Operation: Inoperative The unit is nearing the end of the manufactures stated design life, A qualified air conditioning contractor is recommended to evaluate and estimate repairs
8. West Side AC System Exterior Unit: Mounted on wooden platform Wooden platform is deteriorated and needs to be repaired.

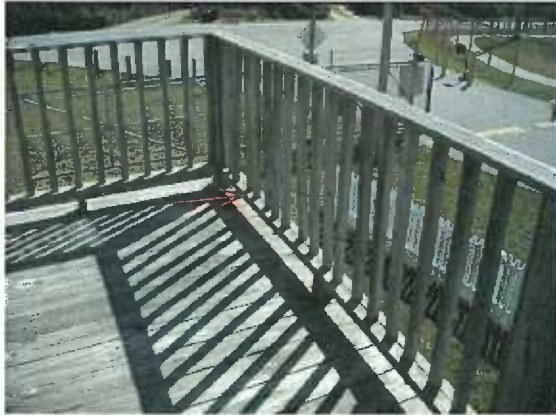
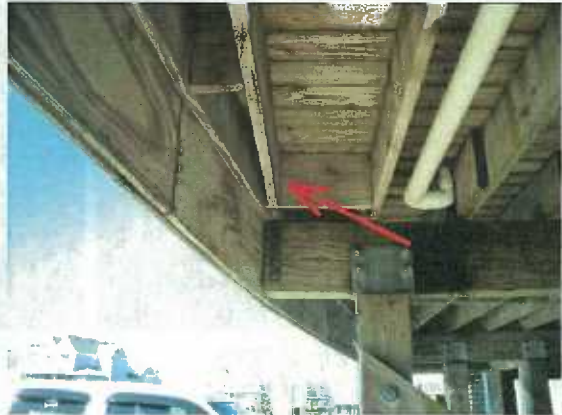
2. ☐ ☐ ☐ ☒ ☐ Deck: Front, Pressure Treated Wood There is one floor joist near the front of the deck that is not properly supported with a metal joist hanger. Several of the handrail pickets are loose and out of place. Close inspection revealed that the nails used to fasten the pickets to the top and bottom rails are rusty and deteriorated and failing to perform their intended function.

1. **Deck: Front, Pressure Treated Wood** There is one floor joist near the front of the deck that is not properly supported with a metal joist hanger. Several of the handrail pickets are loose and out of place. Close inspection revealed that the nails used to fasten the pickets to the top and bottom rails are rusty and deteriorated and failing to perform their intended function.

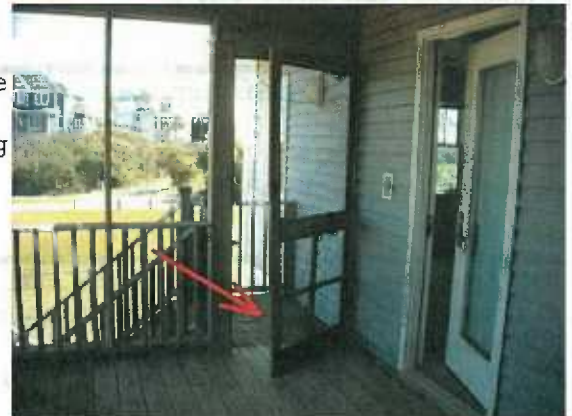
3. ☐ ☐ ☐ ☐ ☒ Porch: Rear Porch, Pressure Treated Wood The porch ledger supporting the floor joist, this girder is not bolted to the structure. Screen panels for the porch are missing or damaged. The porch screen door is damaged.

1. Porch: Rear Porch, Pressure Treated Wood The porch ledger supporting the floor joist, this girder is not bolted to the structure. Screen panels for the porch are missing or damaged. The porch screen door is damaged.

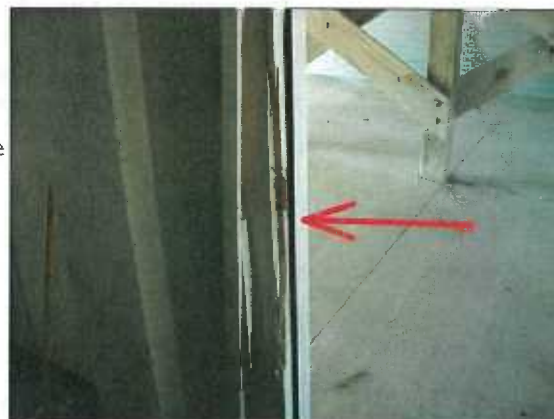
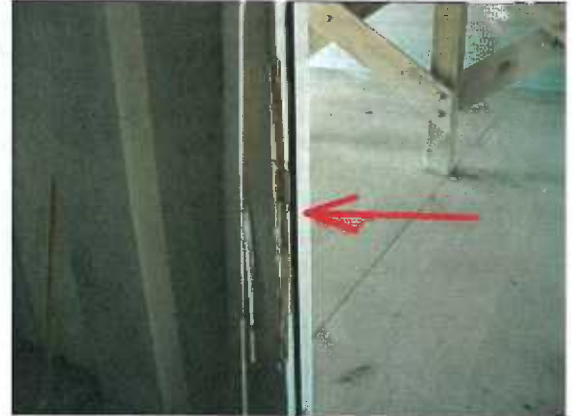
12. ☐ ☐ ☐ ☐ ☒ properly.
Entry Door: Ground Utility Room, Fiberglass, Flush Solid Core This door has been forced open since the last visit to this site. It appears the door was kicked open. The opening edge of the door jamb and the inside door casing was damaged.

4. Entry Door: Ground Utility Room, Fiberglass, Flush Solid Core This door has been forced open since the last visit to this site. It appears the door was kicked open. The opening edge of the door jamb and the inside door casing was damaged.

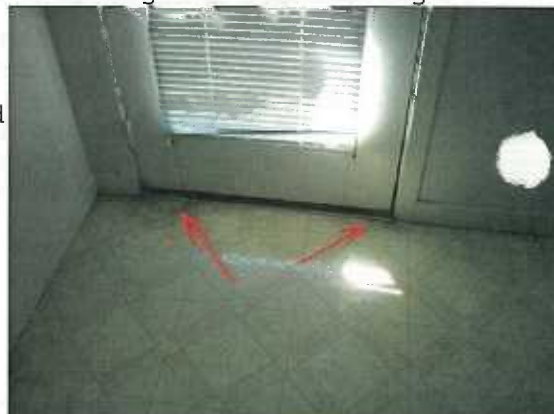
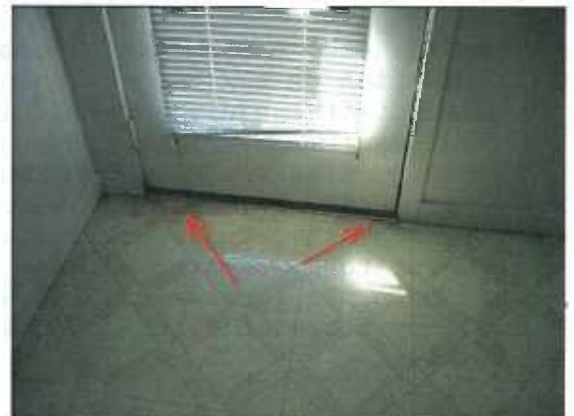
14. ☐ ☐ ☐ ☒ ☐ Entry Door: Kitchen/Dining Area, Fiberglass, Fullview Glass Moisture is migrating to the inside at the door threshold. The door and threshold need to be adjusted to stop the moisture migration.

5. Entry Door: Kitchen/Dining Area, Fiberglass, Fullview Glass Moisture is migrating to the inside at the door threshold. The door and threshold need to be adjusted to stop the moisture migration.

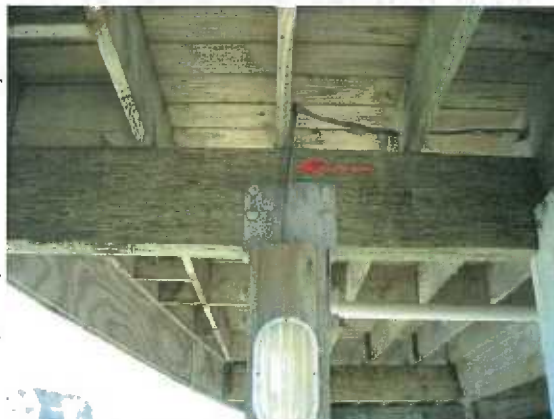
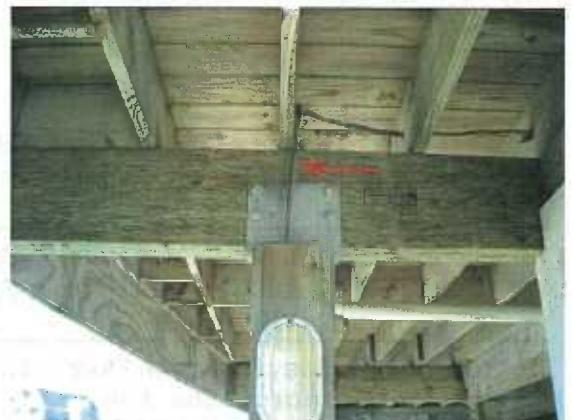
17. ☐ ☐ ☐ ☐ ☒ Exterior Lighting: Exterior, Surface Mount
There is a exterior light under the front deck that was wired with interior romex wiring that should have been installed in electrical conduit. There is a light installed for the rear stairs. The interior romex wiring for this light should have been installed in electrical conduit. There is a light installed for the rear stairs. The underground romex wiring for this light should have been installed in electrical conduit. There is a light installed for the rear stairs. The underground romex wiring for this light should have been installed in electrical conduit.

6. Exterior Lighting: Exterior, Surface Mount There is a exterior light under the front deck that was wired with interior romex wiring that should have been installed in electrical conduit. There is a light installed for the rear stairs. The interior romex wiring for this light should have been installed in electrical conduit. There is a light installed for the rear stairs. The underground romex wiring for this light should have been installed in electrical conduit. There is a light installed for the rear stairs. The underground romex wiring for this light should have been installed in electrical conduit.

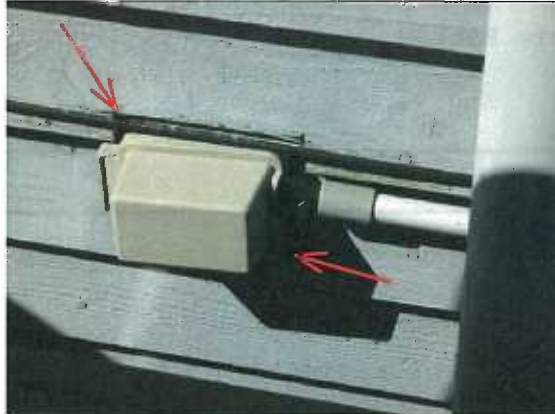
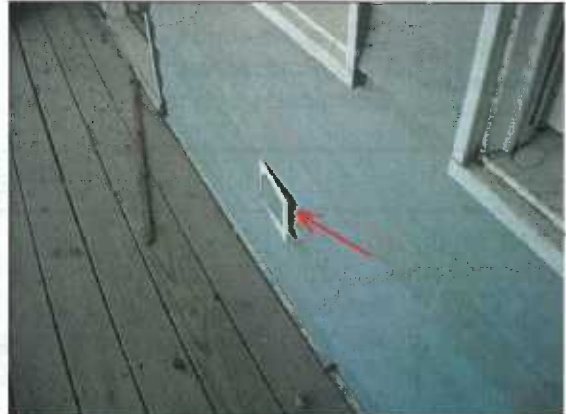
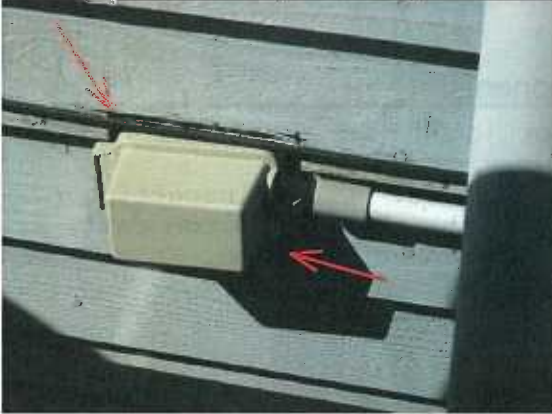
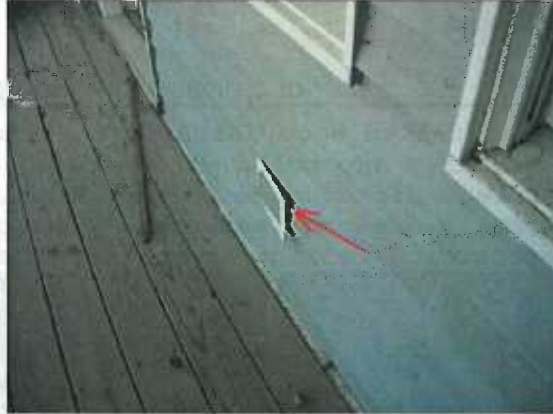
18. ☐ ☐ ☐ ☒ ☐ Exterior Electric Outlets: Exterior, Surface Mount The exterior electrical outlets are not properly mounted to the wall.

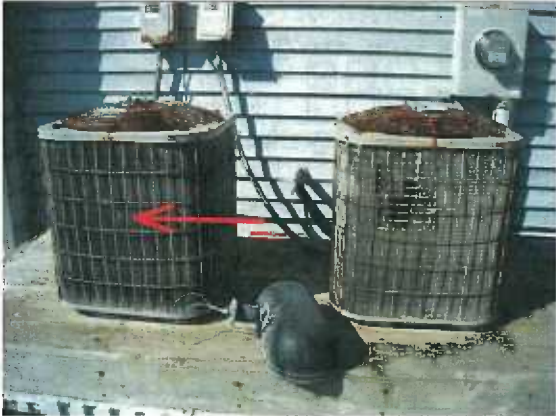
8. ☐ ☐ ☐ ☐ ☒ Visible Coil: Copper core with aluminum fins
The aluminum fins surrounding the copper coil are becoming deteriorated and falling away from the copper coil. The aluminum fins are present to dissipate the heat from the copper coil and when the fins are no longer present the coil will over heat and the condenser will cease to function.

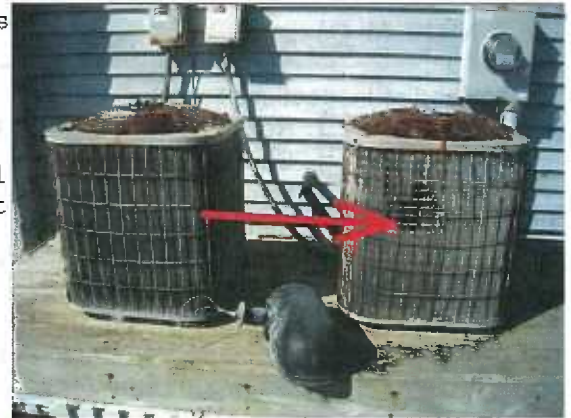
18. ☐ ☐ ☐ ☐ ☒ **Visible Coil:** Copper core with aluminum fins
The aluminum fins surrounding the copper coil are becoming deteriorated and falling away from the copper coil. The aluminum fins are present to dissipate the heat from the copper coil and when the fins are no longer present the coil will over heat and the condenser will cease to function.

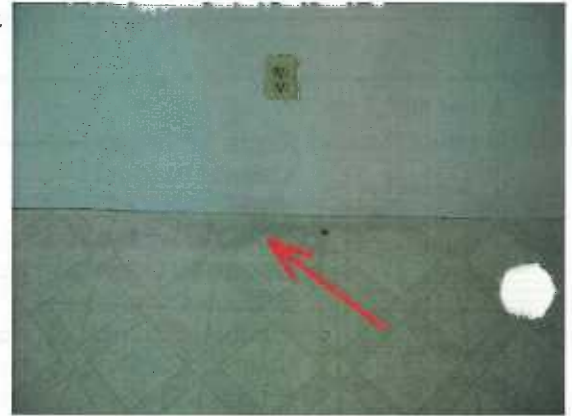
| 12. | <input type="checkbox"/> | <input type="checkbox"/> | <input type="checkbox"/> | <input type="checkbox"/> | <input checked="" type="checkbox"/> | Floor: Vinyl floor covering There are cut in the vinyl flooring and a stain in the area of the party wall. |

17. Kitchen & Dining Area, Main Level Kitchen Floor: Vinyl floor covering There are cut in the vinyl flooring and a stain in the area of the party wall.

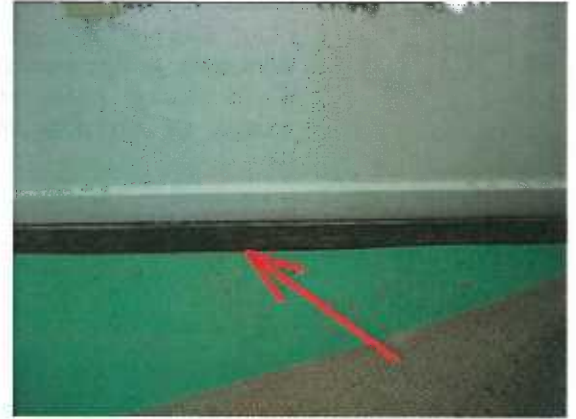
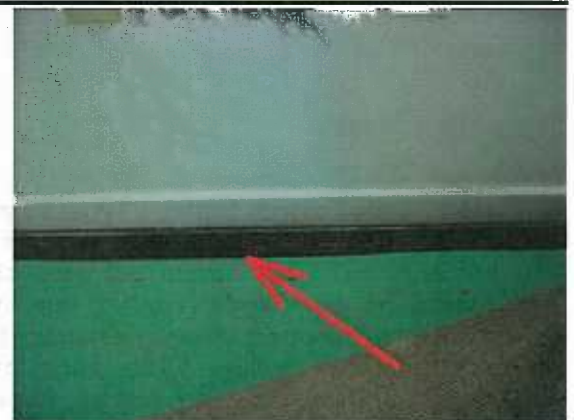
12. ☐ ☐ ☐ ☒ ☐ Floor: Carpet The carpet is wet in the area of the party wall.

9. Top Front Bedroom Floor: Carpet The carpet is wet in the area of the party wall.

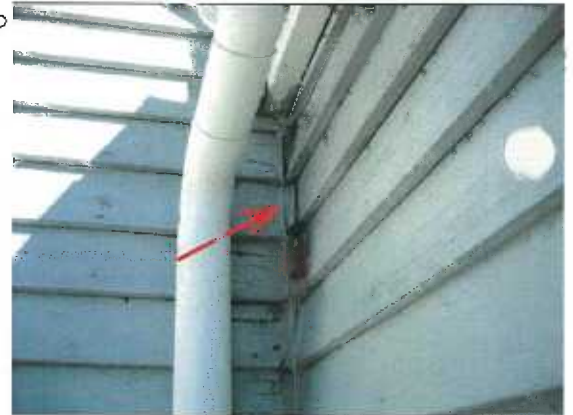
6. ☐ ☐ ☐ ☐ ☒ Type: Horizontal Wood Ship Lap Siding At the front, where the two units are joined, the siding and possibly the sub-siding and framing is deteriorated, All exterior wall surfaces should be examined and re nailed in the areas where is has become loose. The exterior of the house should be pressure washed and repainted.

2. Exterior Walls Exterior Surface Type: Horizontal Wood Ship Lap Siding At the front, where the two units are joined, the siding and possibly the sub-siding and framing is deteriorated, All exterior wall surfaces should be examined and re nailed in the areas where is has become loose. The exterior of the house should be pressure washed and repainted.

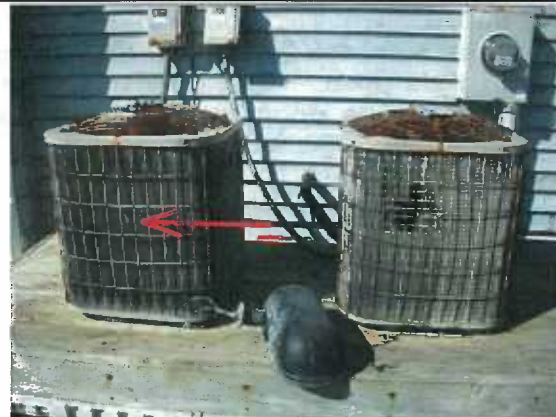
8. East Side of House AC System Visible Coil: Copper core with aluminum fins The aluminum fins surrounding the copper coil are becoming deteriorated and falling away from the copper coil. The aluminum fins are present to dissipate the heat from the copper coil and when the fins are no longer present the coil will over heat and the condenser will cease to function.

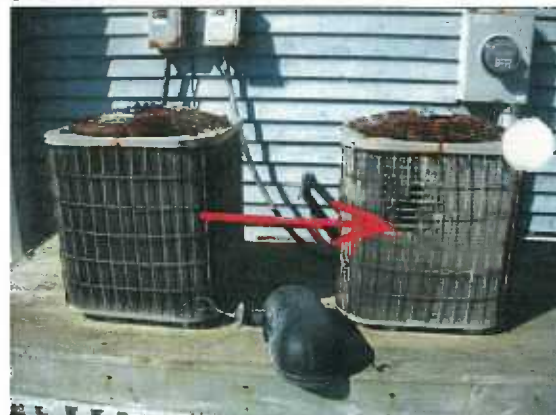
9. East Side of House AC System Refrigerant Lines: Rubbertex Insulation The black rubbertex insulation on the copper tubing is deteriorated and should be replaced.
10. East Side of House AC System A/C System Operation: Inoperative
11. East Side of House AC System Visible Coil: Copper core with aluminum fins The aluminum fins surrounding the copper coil are becoming deteriorated and falling away from the copper coil. The aluminum fins are present to dissipate the heat from the copper coil and when the fins are no longer present the coil will over heat and the condenser will cease to function.

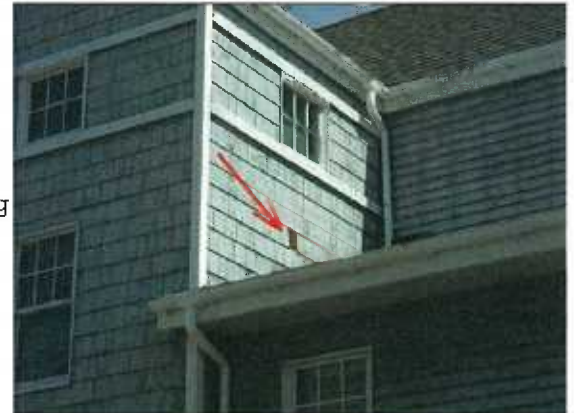
7. ☐ ☐ ☐ ☒ ☐ Type: Plywood Panels with machine shake appearance. There is one piece of the wood shake shingle panel missing from the wall, The machine shake look plywood panels, the nails are loose in several places. The exterior walls should be examined and the loose siding re nailed. The exterior of the house should be pressure washed and repainted.

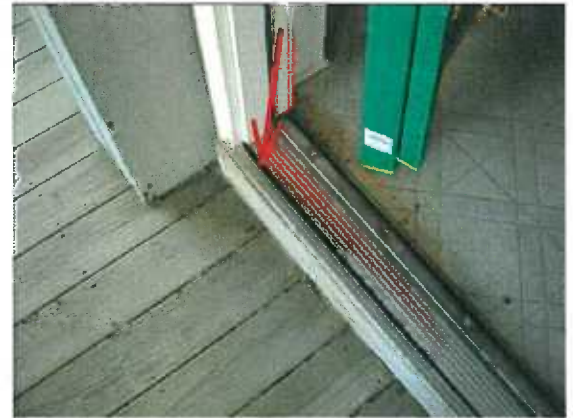
11. ☐ ☐ ☐ ☐ ☒ Entry Doors: Ground Front, Fiberglass, Full View Glass The door threshold is made of two pieces of aluminum. The two pieces have separated.

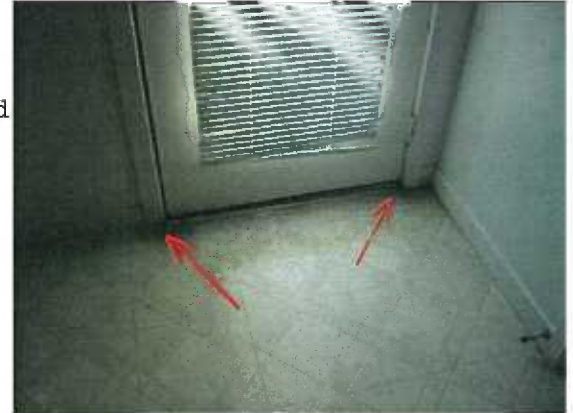
14. ☐ ☐ ☐ ☐ ☒ Entry Door: Kitchen/Dining Area, Fiberglass, Fullview Glass Moisture is migrating to the inside at the door threshold. The door and threshold need to be adjusted to stop the moisture migration. The sub floor on the inside is deteriorated and the vinyl flooring is damaged/deteriorated.

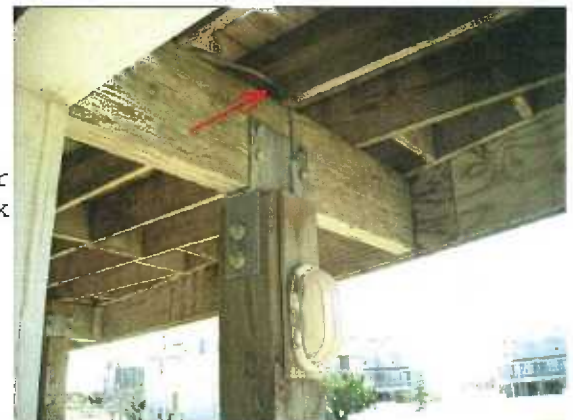
17. ☐ ☐ ☐ ☒ ☐ Exterior Lighting: Exterior, Surface Mount There is a exterior light under the front deck that was wired with underground romex wiring that should have been installed in electrical conduit. There is a light installed for the rear stairs. The underground romex wiring for this light should have been installed in electrical conduit.
